# **BELLEFONTE ASD**

## **BUILDING CONDITIONS**

### **SURVEY RESULTS**

# BELLEFONTE ELEMENTARY

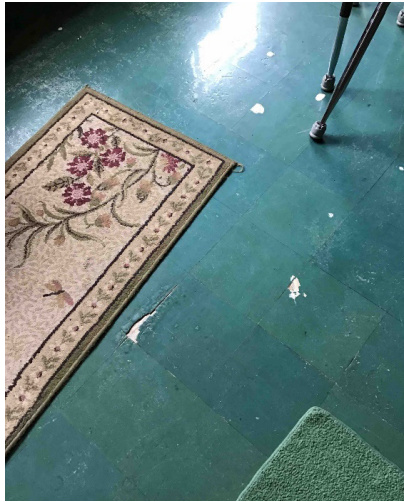
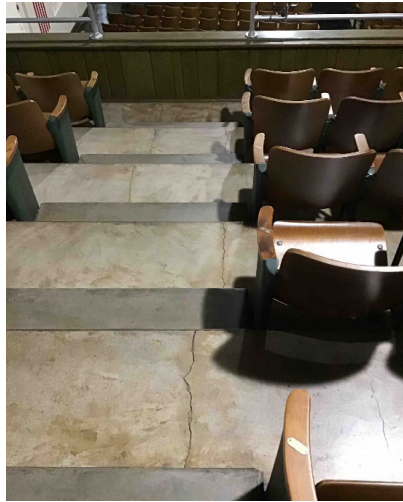
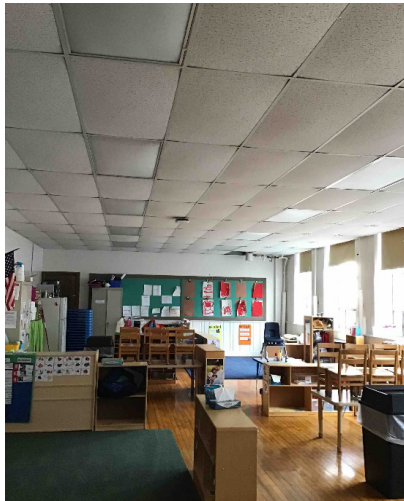
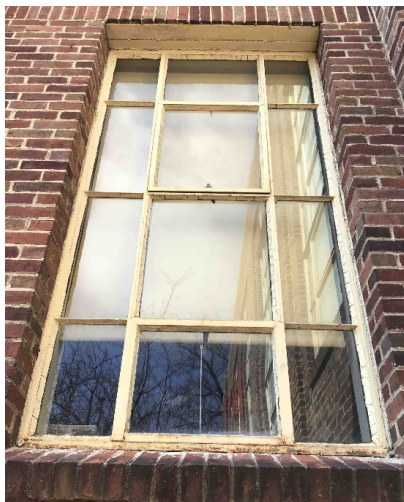
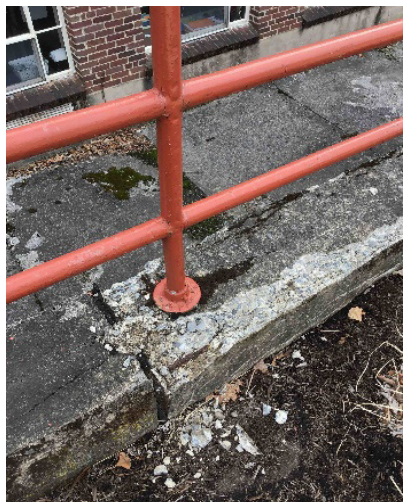
- Corridor Doors are not Fire Rated

- Toilet Rooms; aged and non-compliant
- Handrails, Stage/Balcony; non-compliant
- No Elevator for access between floors

- Auditorium Upgrades; Ceiling, Seating
- Classroom Ceiling Replacement
- Flooring over Wood Floors
- Replace Classroom Casework
- Replace Windows (Original)
- Masonry Restoration
- Roof Replacement
- Flooring Replacement

- Asphalt Replacement
- Concrete Sidewalks and Retaining Walls
- No Accessible Route

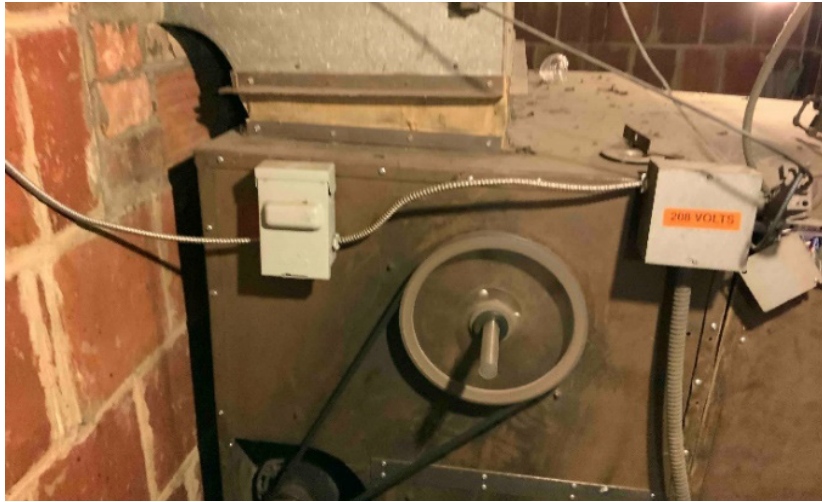
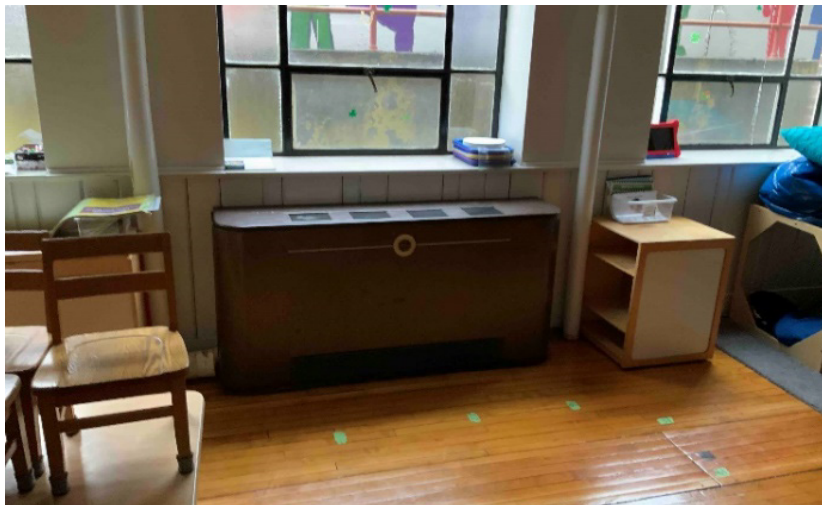
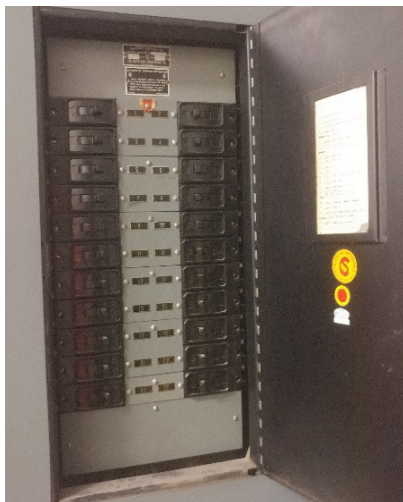
- Gym Air Handling Unit Replacement
- Unit Ventilator Replacement
- Classroom Relief Air
- Non-Ventilated Spaces Occur
- Heating/Cooling System Replacement

- Panel & Fire Alarm Replacement
- Lighting and Controls Upgrades
- Replace Generator

- Relocate MDF/IDF to dedicated space
- Data Cabling Upgrades
- Wireless Access Points
- Security Cameras
- Classroom Displays
- Intercoms/Lockdown System

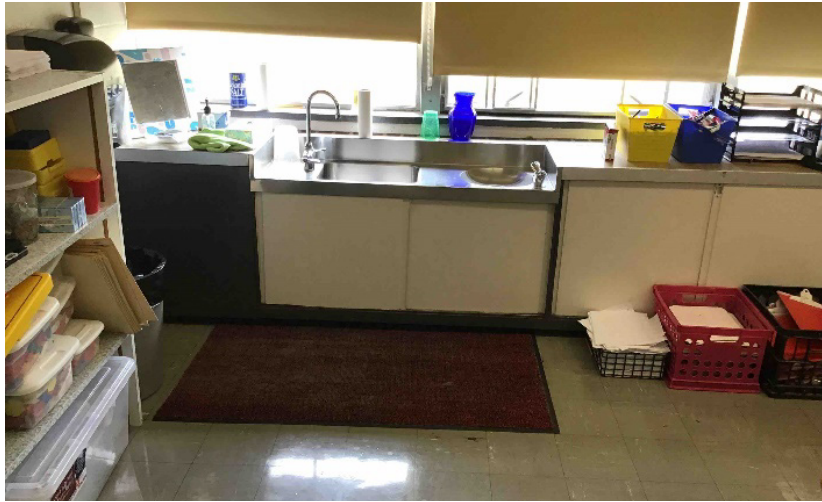
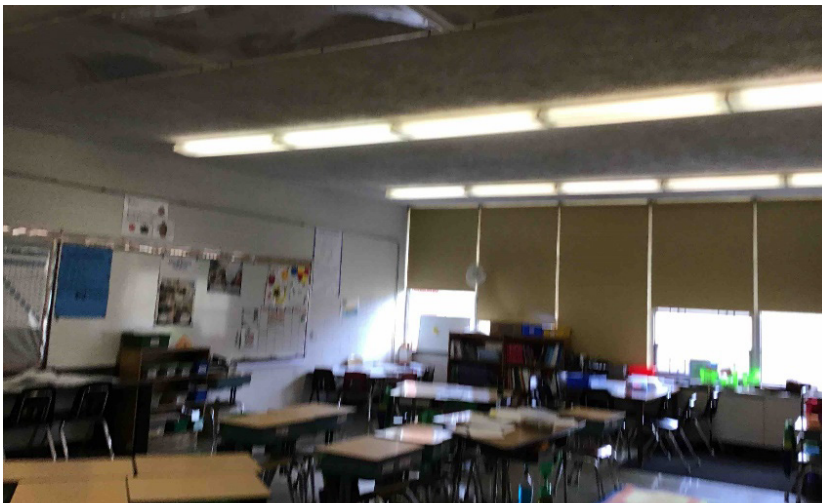
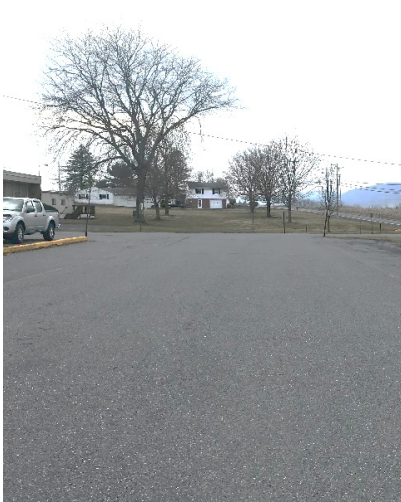
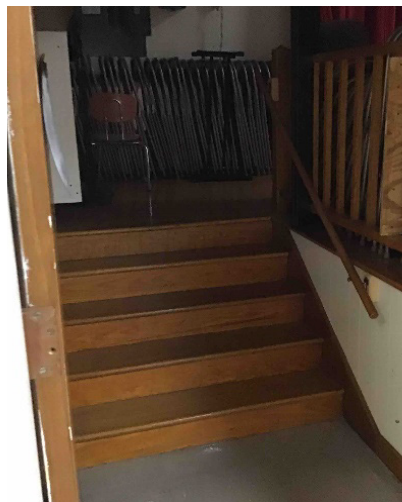
# BENNER ELEMENTARY

- Corridor & Kitchen Doors are not Fire Rated

- Toilet Rooms; aged and non-compliant
- Nurse Suite; aged and non-compliant
- No ADA Access to Stage

- Flooring Replacement
- Ceiling Replacement
- Replace Classroom Casework
- Replace Exterior Doors & Windows
- Masonry Restoration
- Roof Replacement

- Asphalt Replacement
- Concrete Sidewalks and Retaining Walls
- Playground Improvements
- Parking Lot Lighting

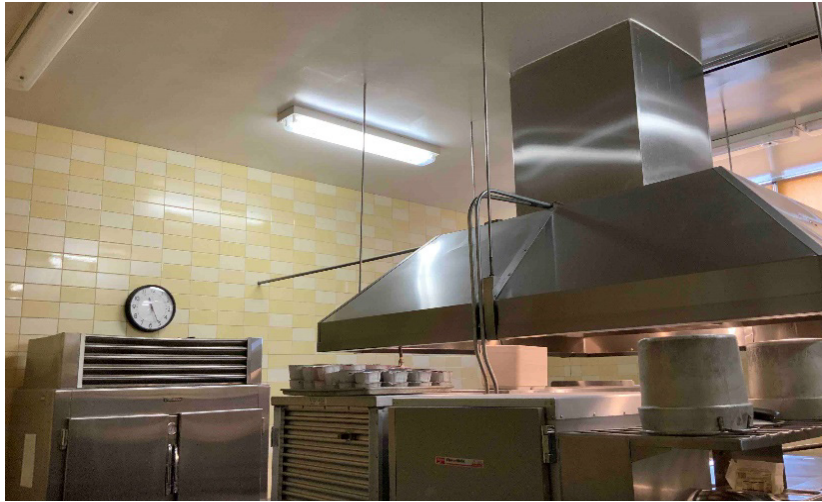
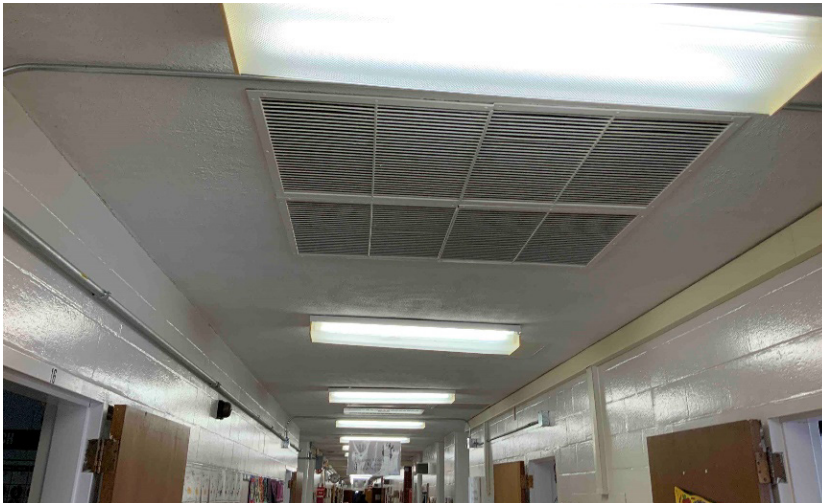
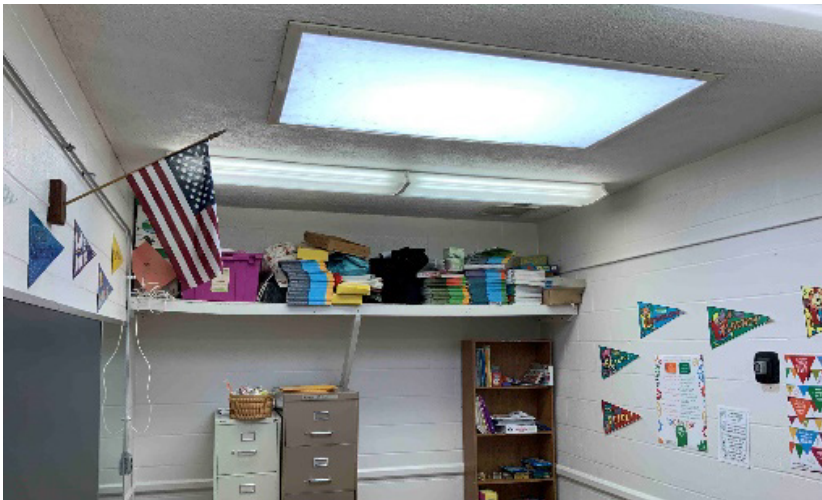
- Kitchen Hood Make Up Air
- Relief Air System Upgrades
- Non-Ventilated Spaces Occur
- Heating/Cooling System Replacement

- Panel Replacement
- Fire Alarm & Exit Lighting Devices
- Lighting and Controls Upgrades
- Replace Generator

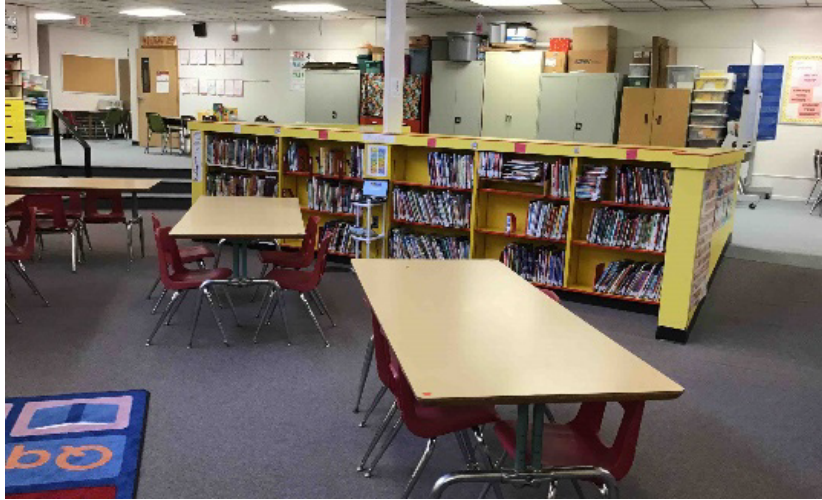
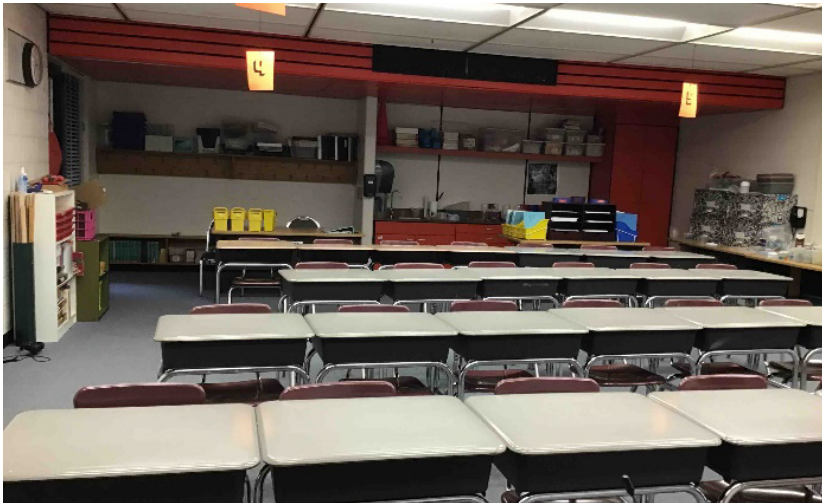
# PLEASANT GAP ELEMENTARY

- Corridor & Kitchen Doors are not Fire Rated
- Exit Width at Means of Egress (Original Building)
- Cubbies in Means of Egress

- Toilet Rooms; aged and non-compliant
- Drinking Fountains; non-compliant
- Handrails; non-compliant
- Library Ramp; non-compliant

- Classroom Ceiling Replacement
- Classroom Flooring (Carpet)
- Replace Classroom & Library Casework
- Replace Aged Exterior Doors, Weatherstripping
- Masonry Restoration
- Roof Replacement, Existing Wood Deck

- Asphalt Replacement
- Concrete Sidewalks and Loading Dock
- Drainage Improvements

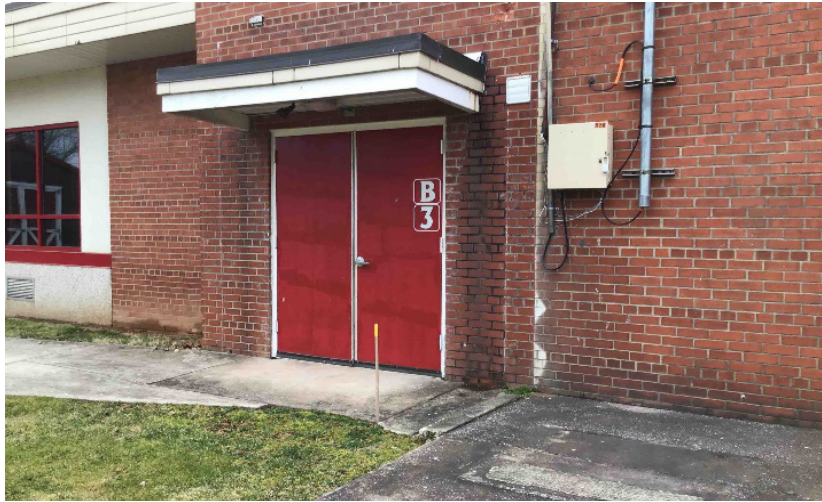
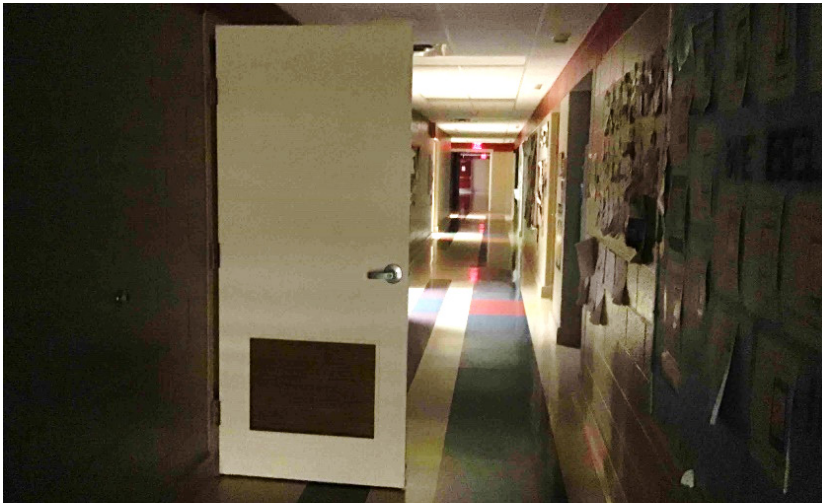
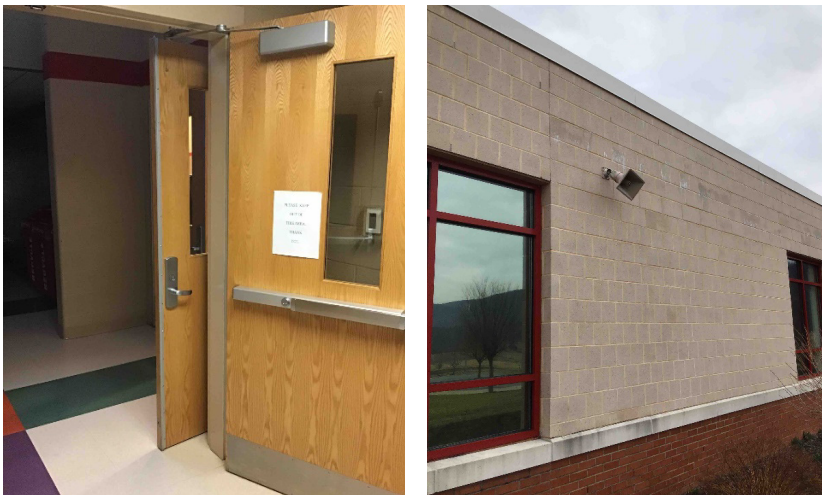
# MARION WALKER ELEMENTARY

- Corridor Doors are not Fire Rated (Original & Multi-Purpose Room)
- Mechanical Door Hold Opens on Doors
- Lack of Second Exit in Kitchen
- Exit Width at Means of Egress (Original Building)

- Faculty Room; non-compliant
- Grab Bars; non-compliant

- Minor Casework Replacement
- Masonry Restoration at Original Brick and New Block
- Roof Replacement

- Asphalt Replacement

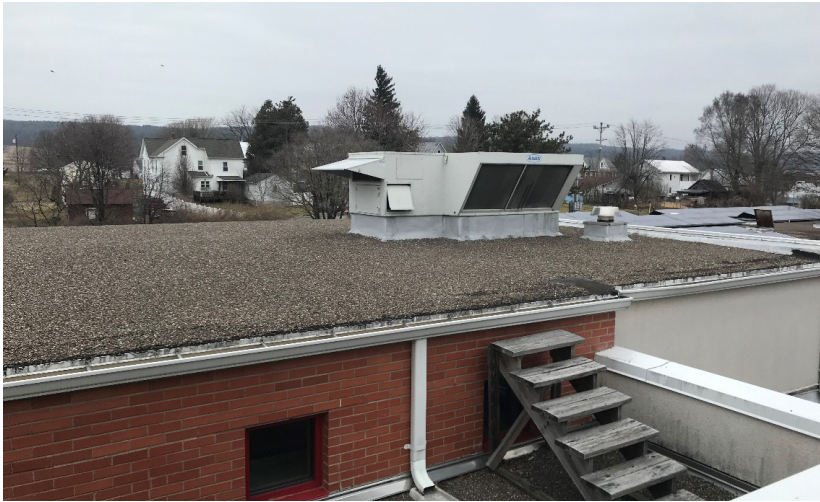
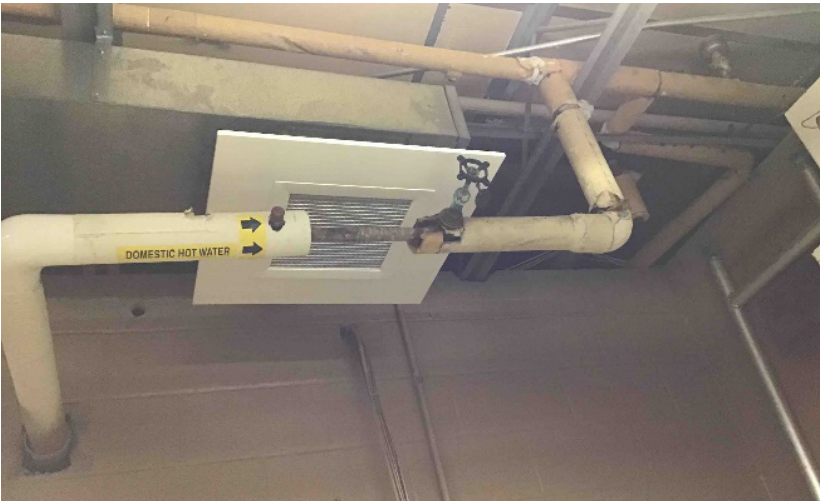
# MARION WALKER ELEMENTARY

- Roof Top Unit Replacement
- Ventilation Air (Temp Classrooms)
- ACM Insulation

- Lighting and Controls Upgrades

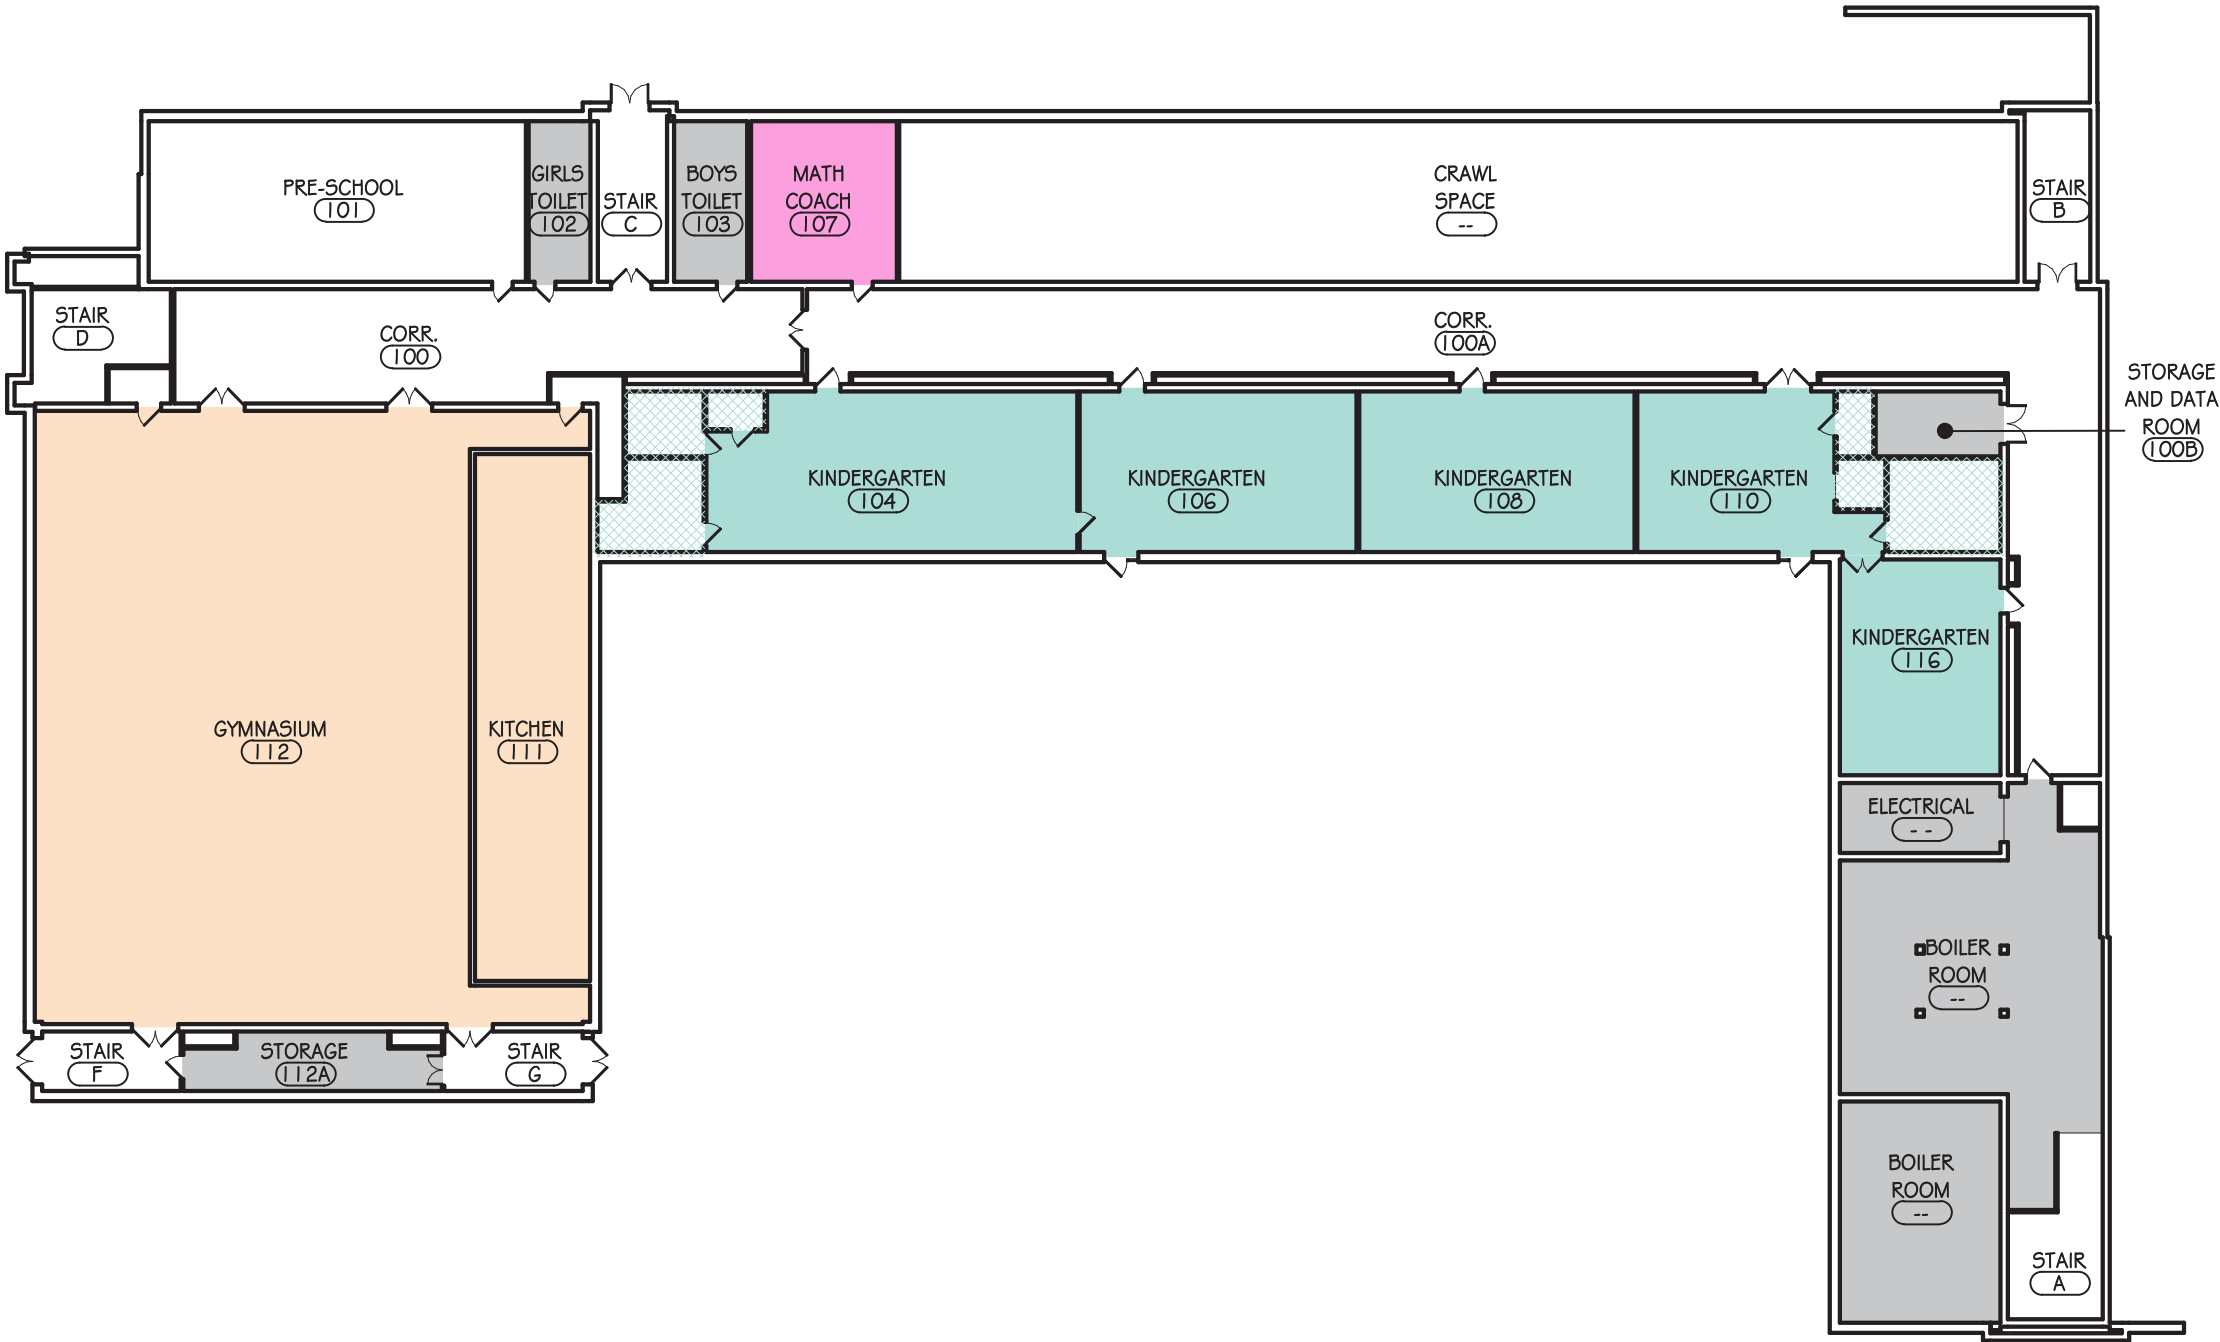
## EXISTING FLOORPLAN - GROUND FLOOR

1 GROUND FLOOR EXISTING PROGRAMMING  
1/32" = 1'-0"

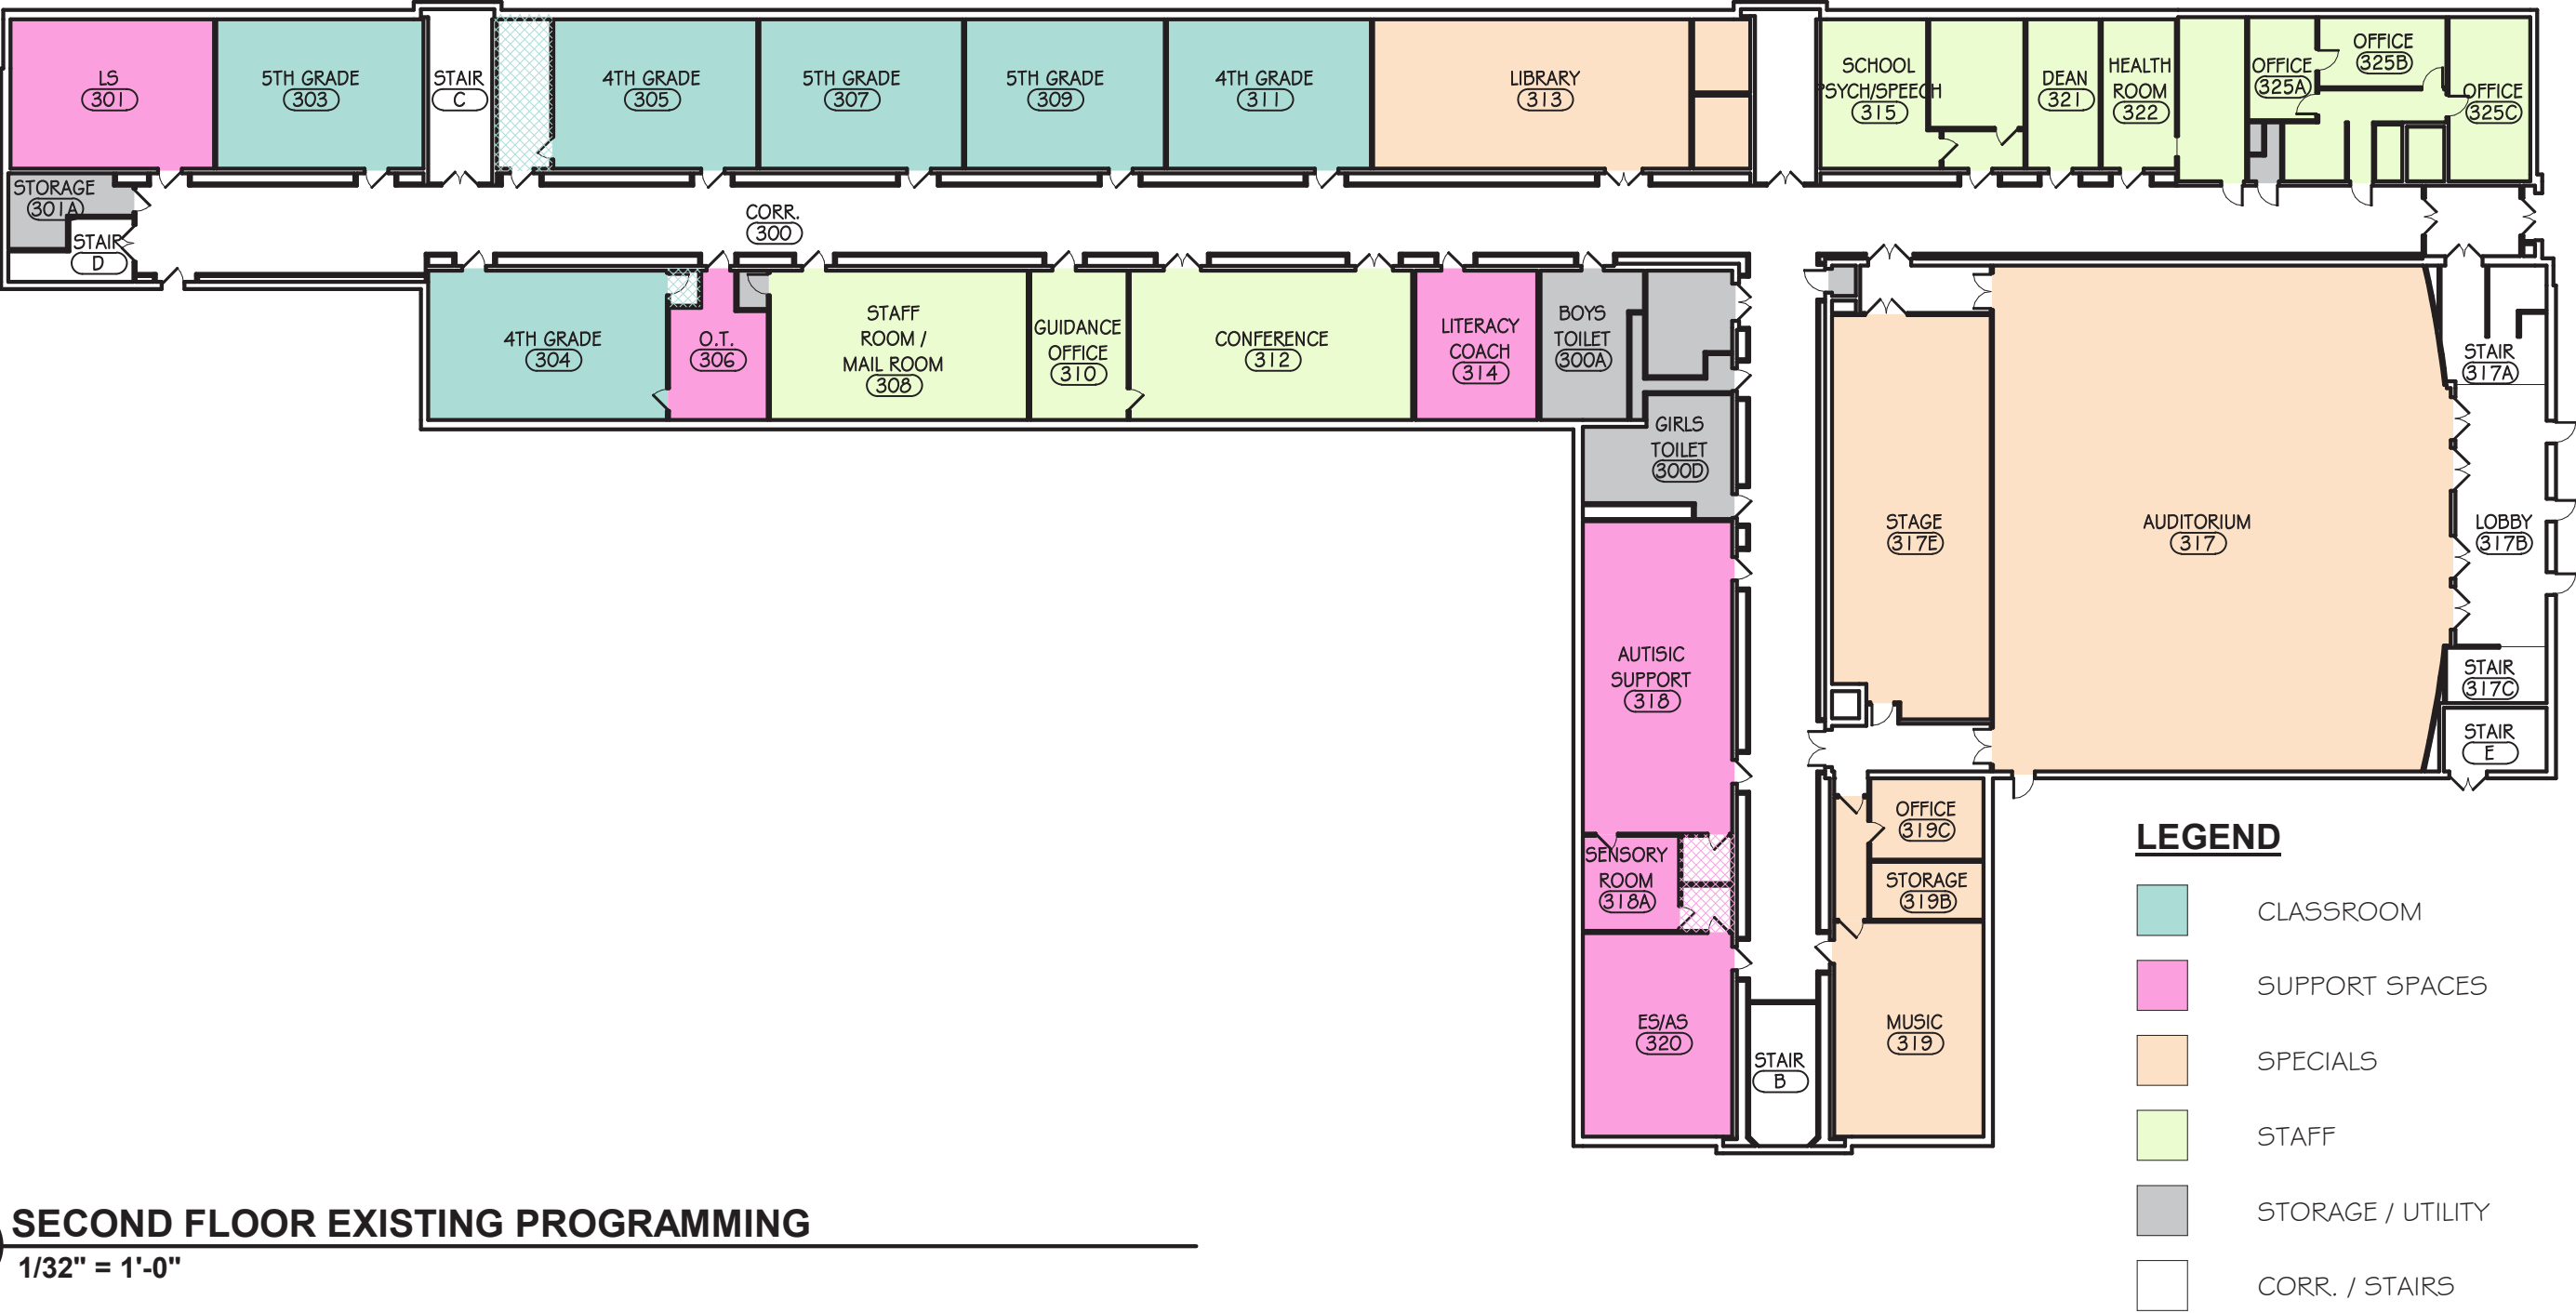
## EXISTING FLOORPLAN - SECOND FLOOR

1 SECOND FLOOR EXISTING PROGRAMMING  
1/32" = 1'-0"

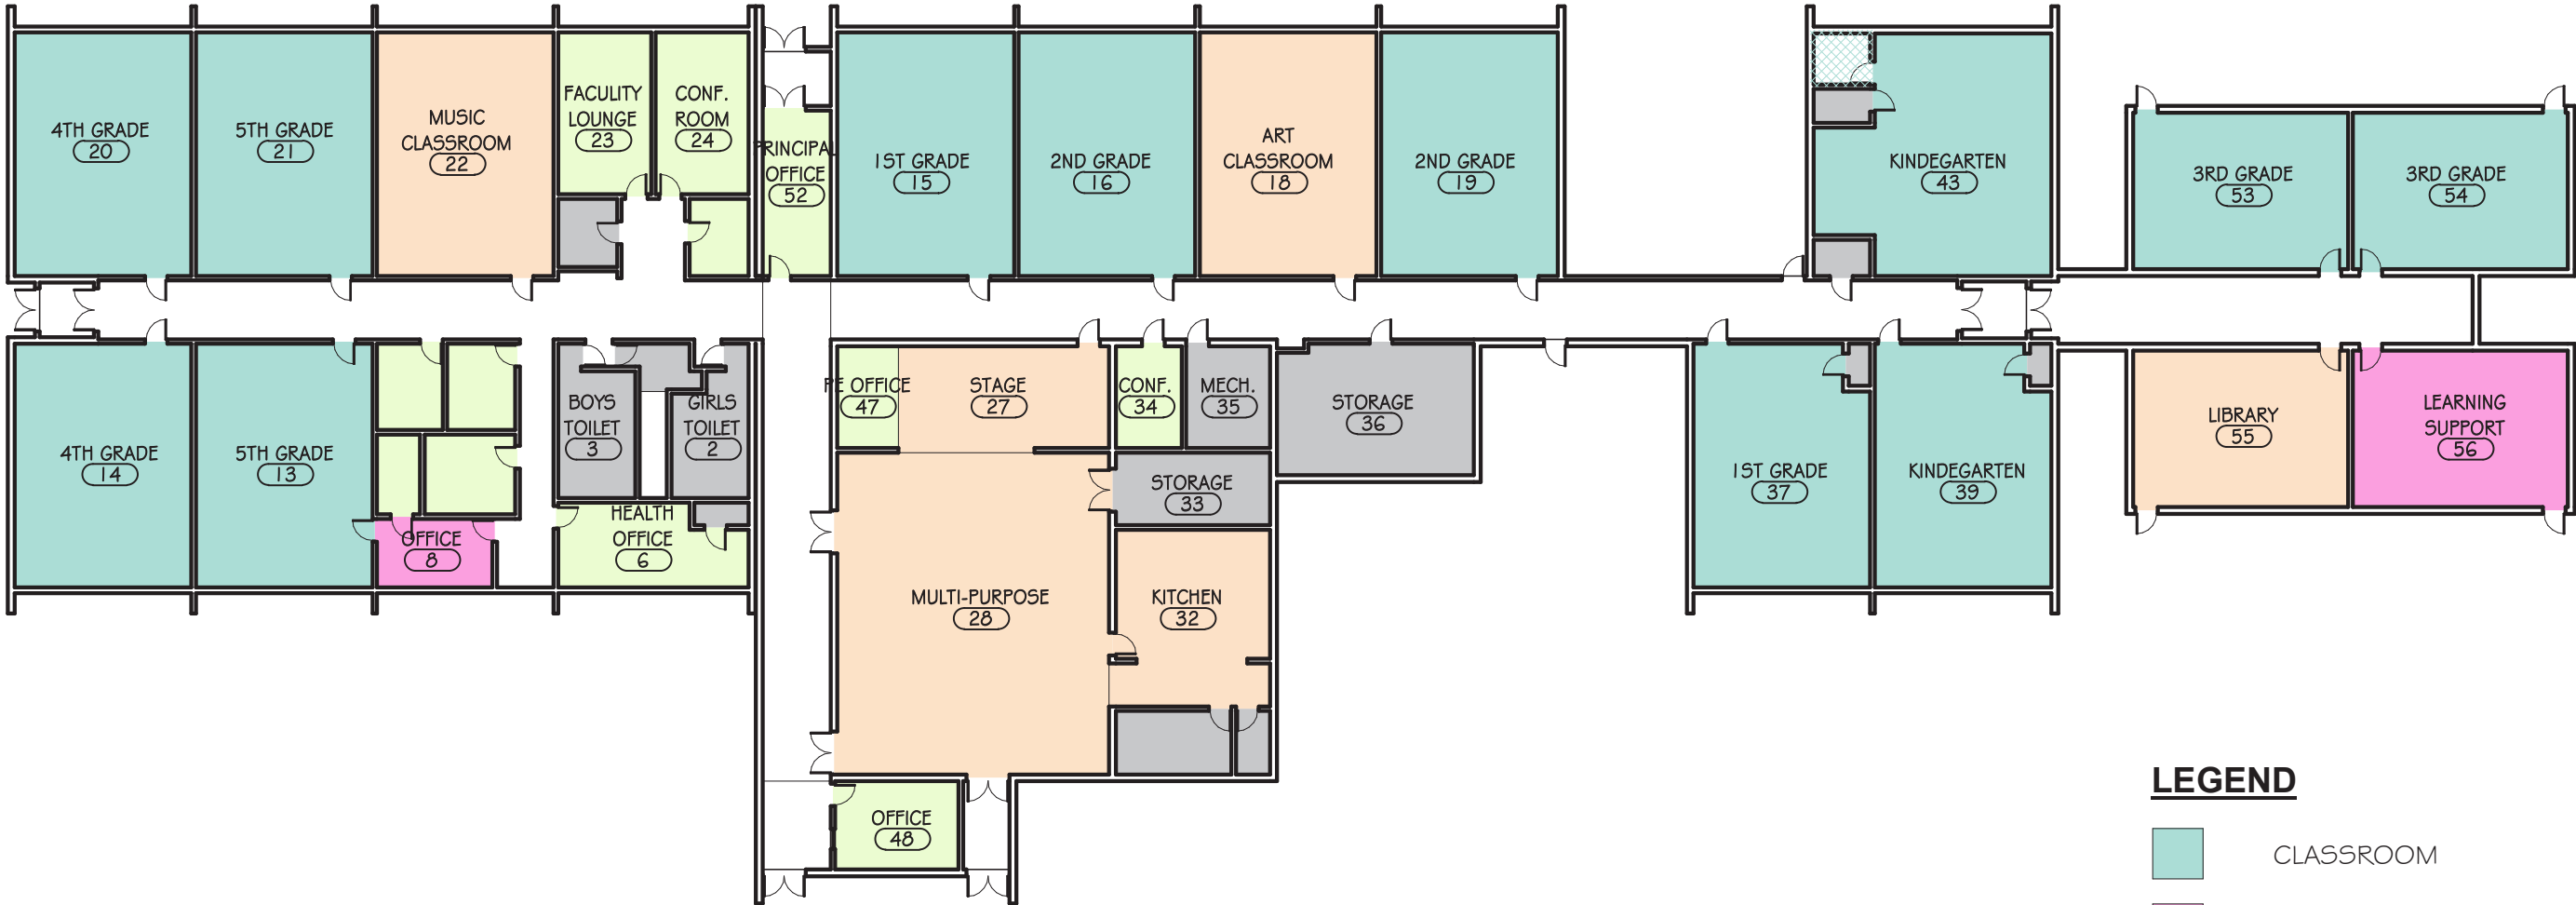
## EXISTING FLOORPLAN

**1** **EXISTING SPACE PROGRAMMING**  
1/32" = 1'-0"

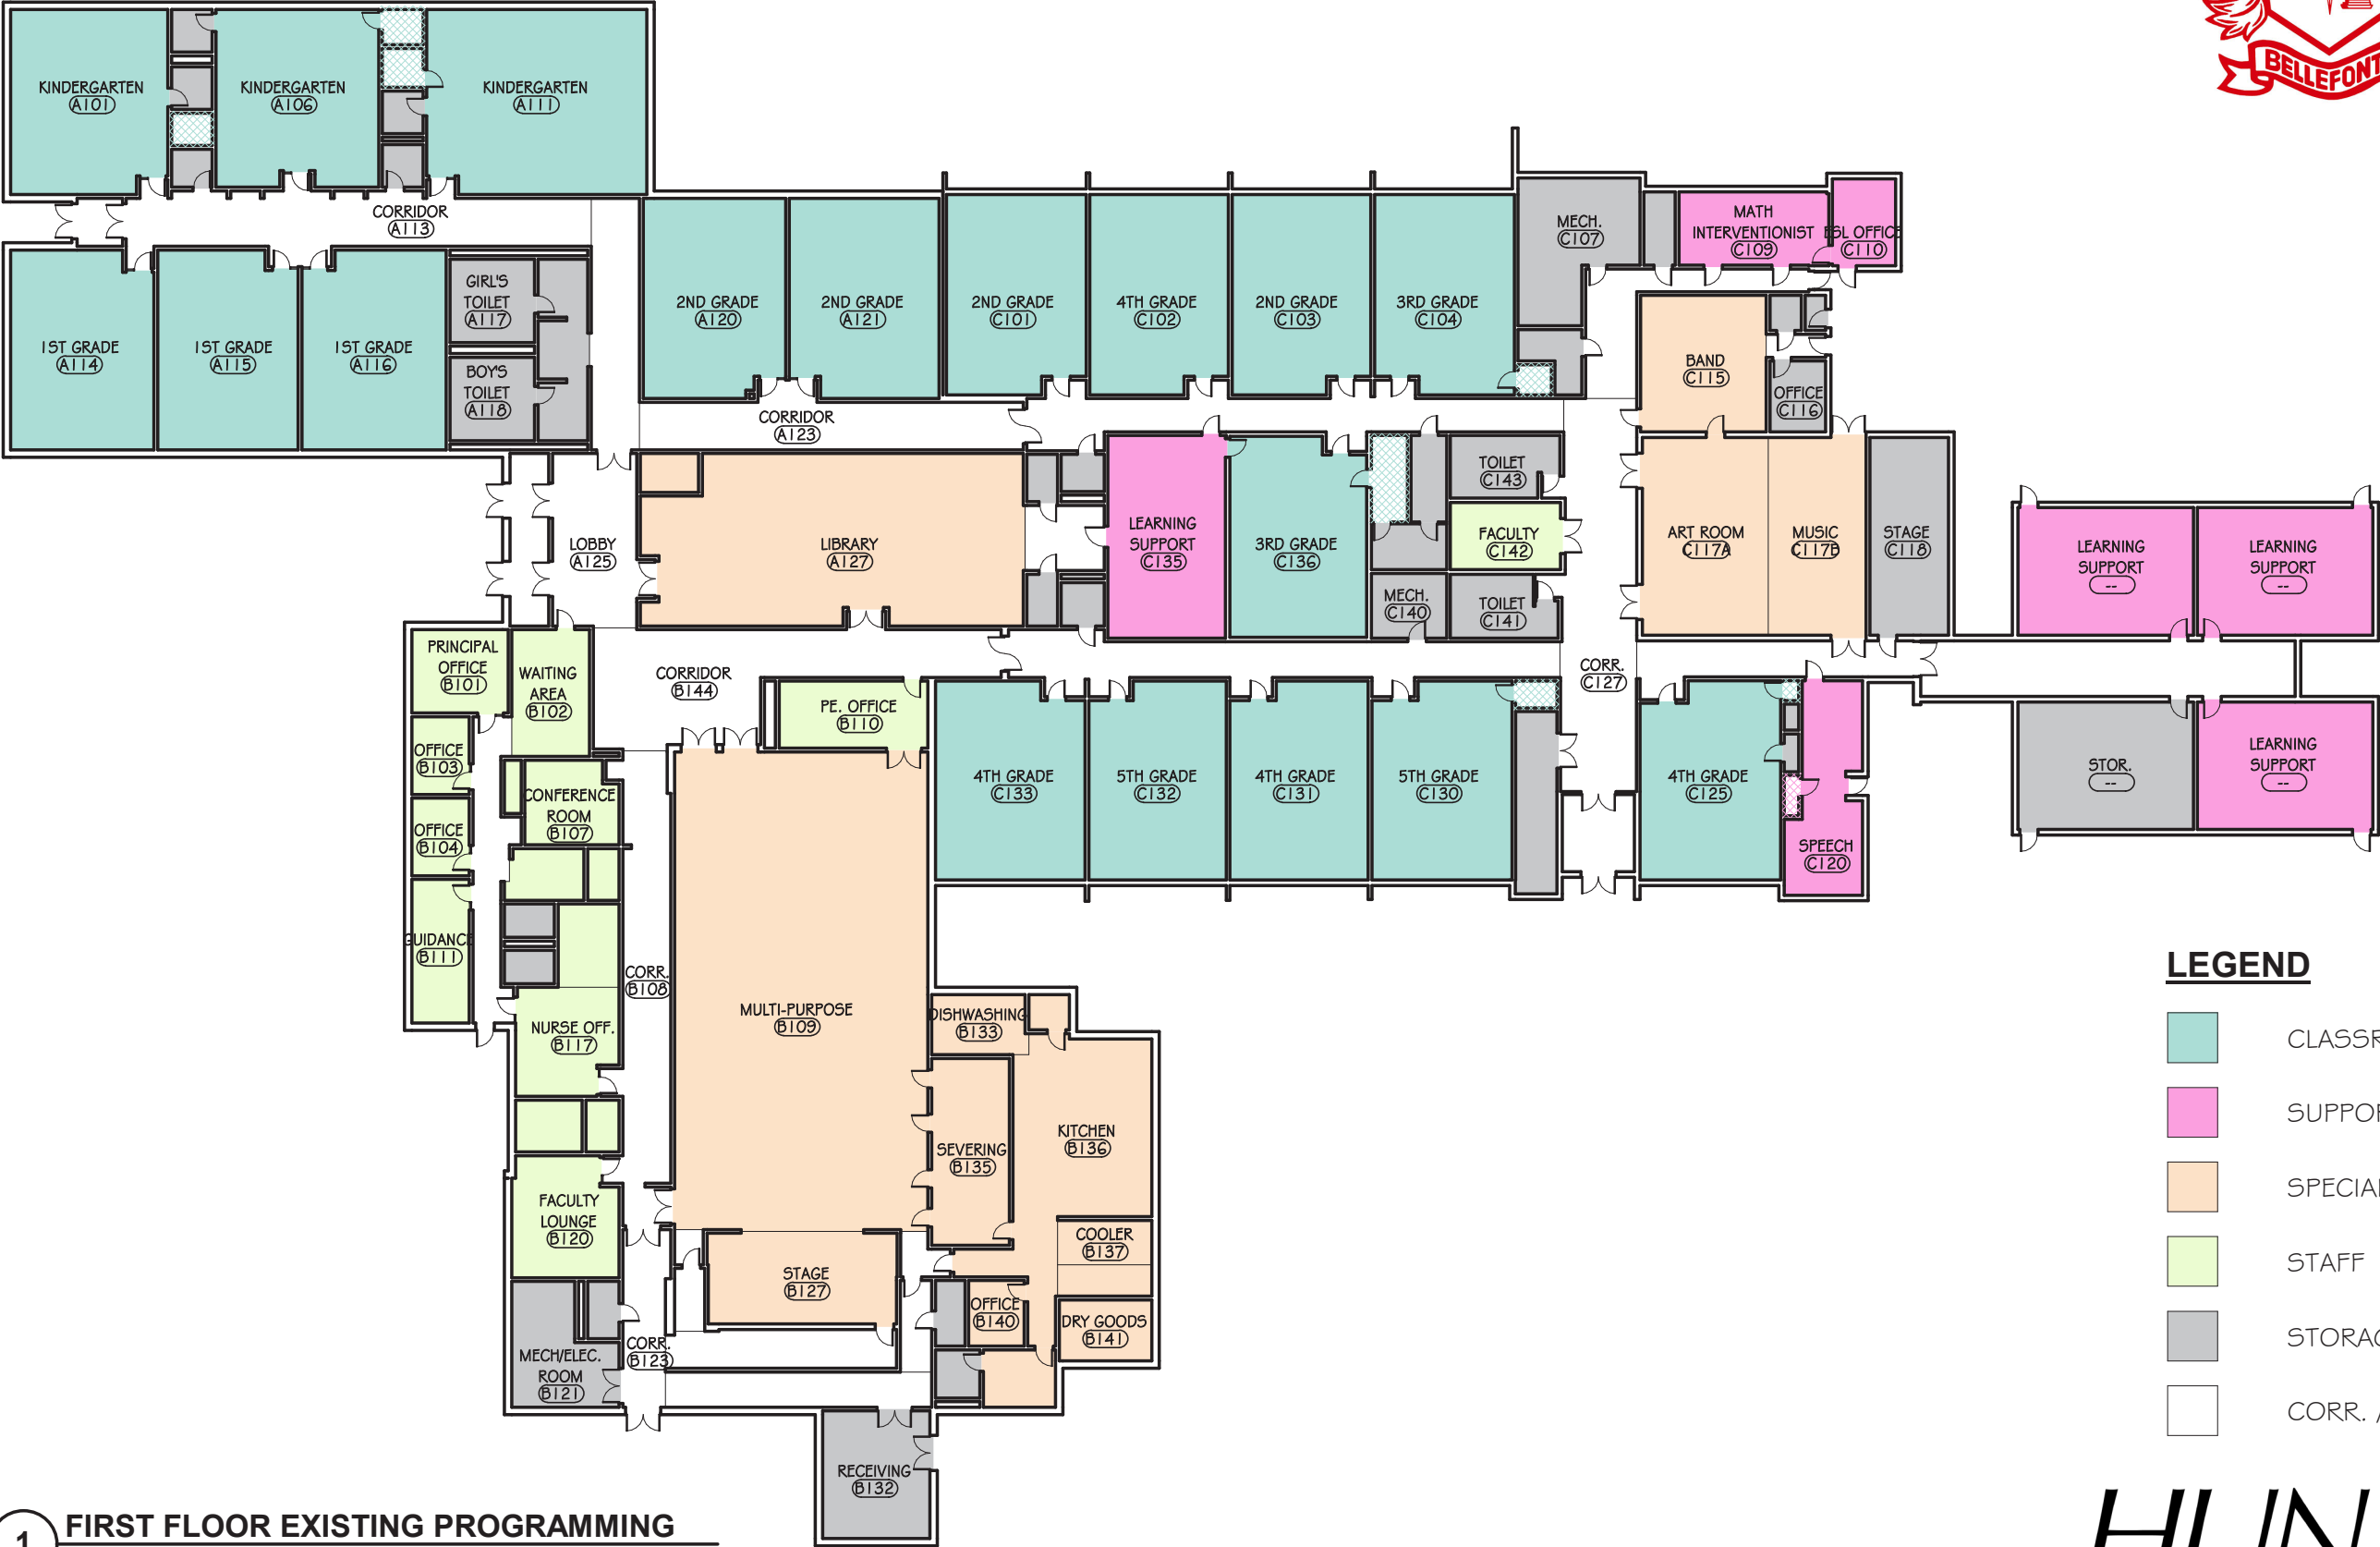
## EXISTING FLOORPLAN

1 FIRST FLOOR EXISTING PROGRAMMING  
1/32" = 1'-0"
