# **BELLEFONTE ASD**

## **BUILDING CONDITIONS**

### **SURVEY RESULTS**

# BELLEFONTE ELEMENTARY

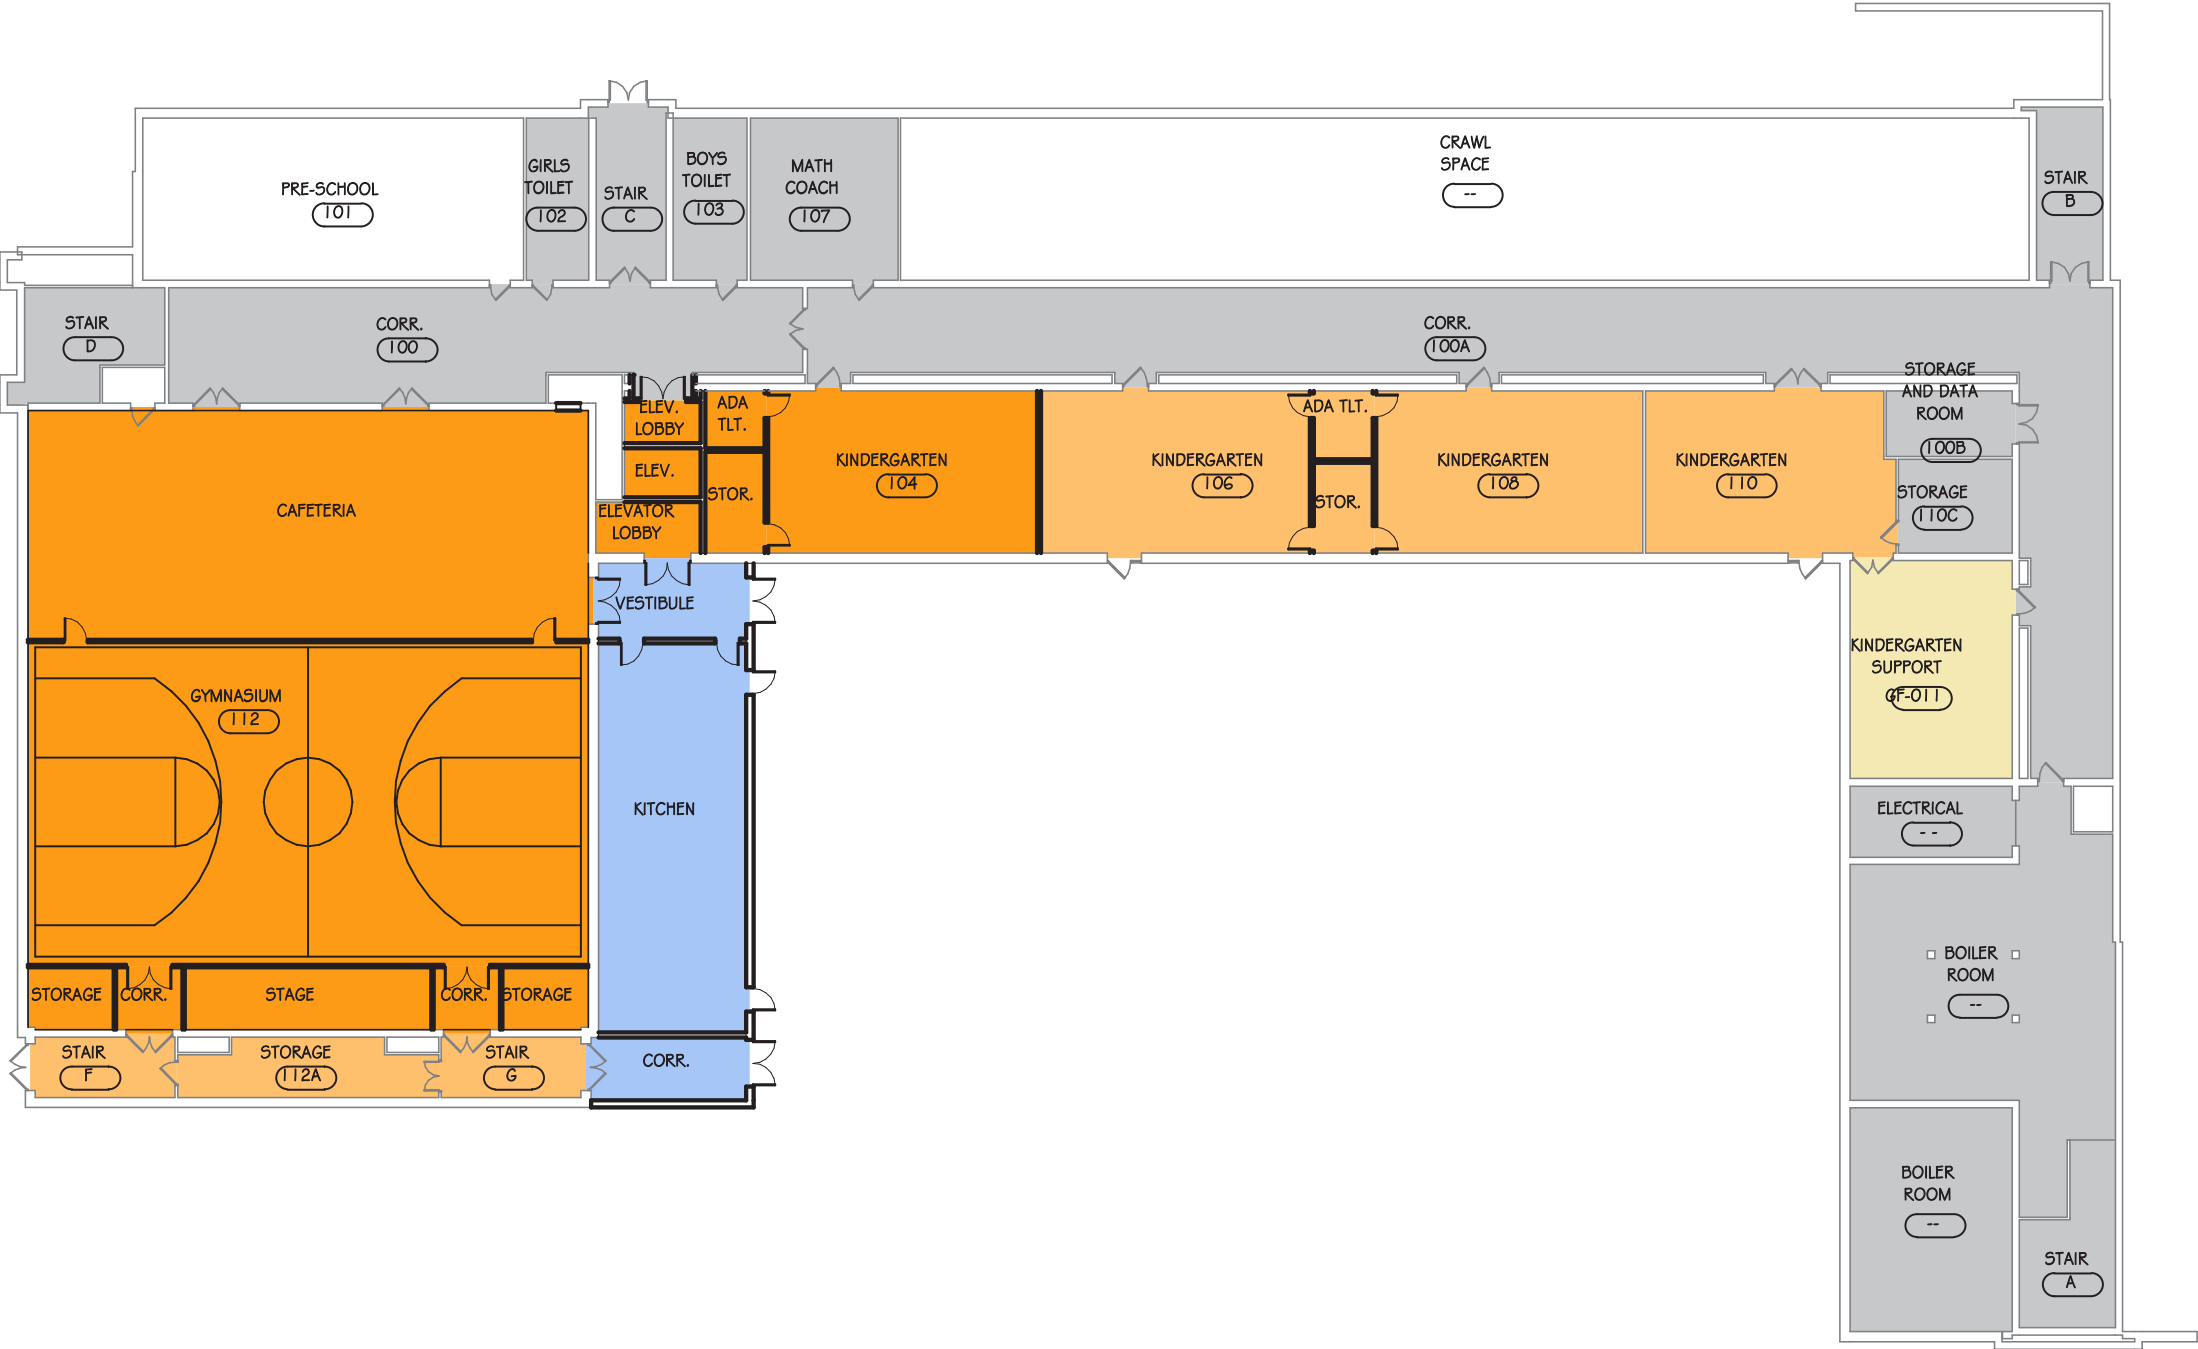
## OPTION 2 FLOORPLAN - GROUND FLOOR

- Multi-purpose Room – With the proposed renovation/re-purposing of the Auditorium, it is recommended that a portion of the existing Multi-purpose Room is renovated into a stage.

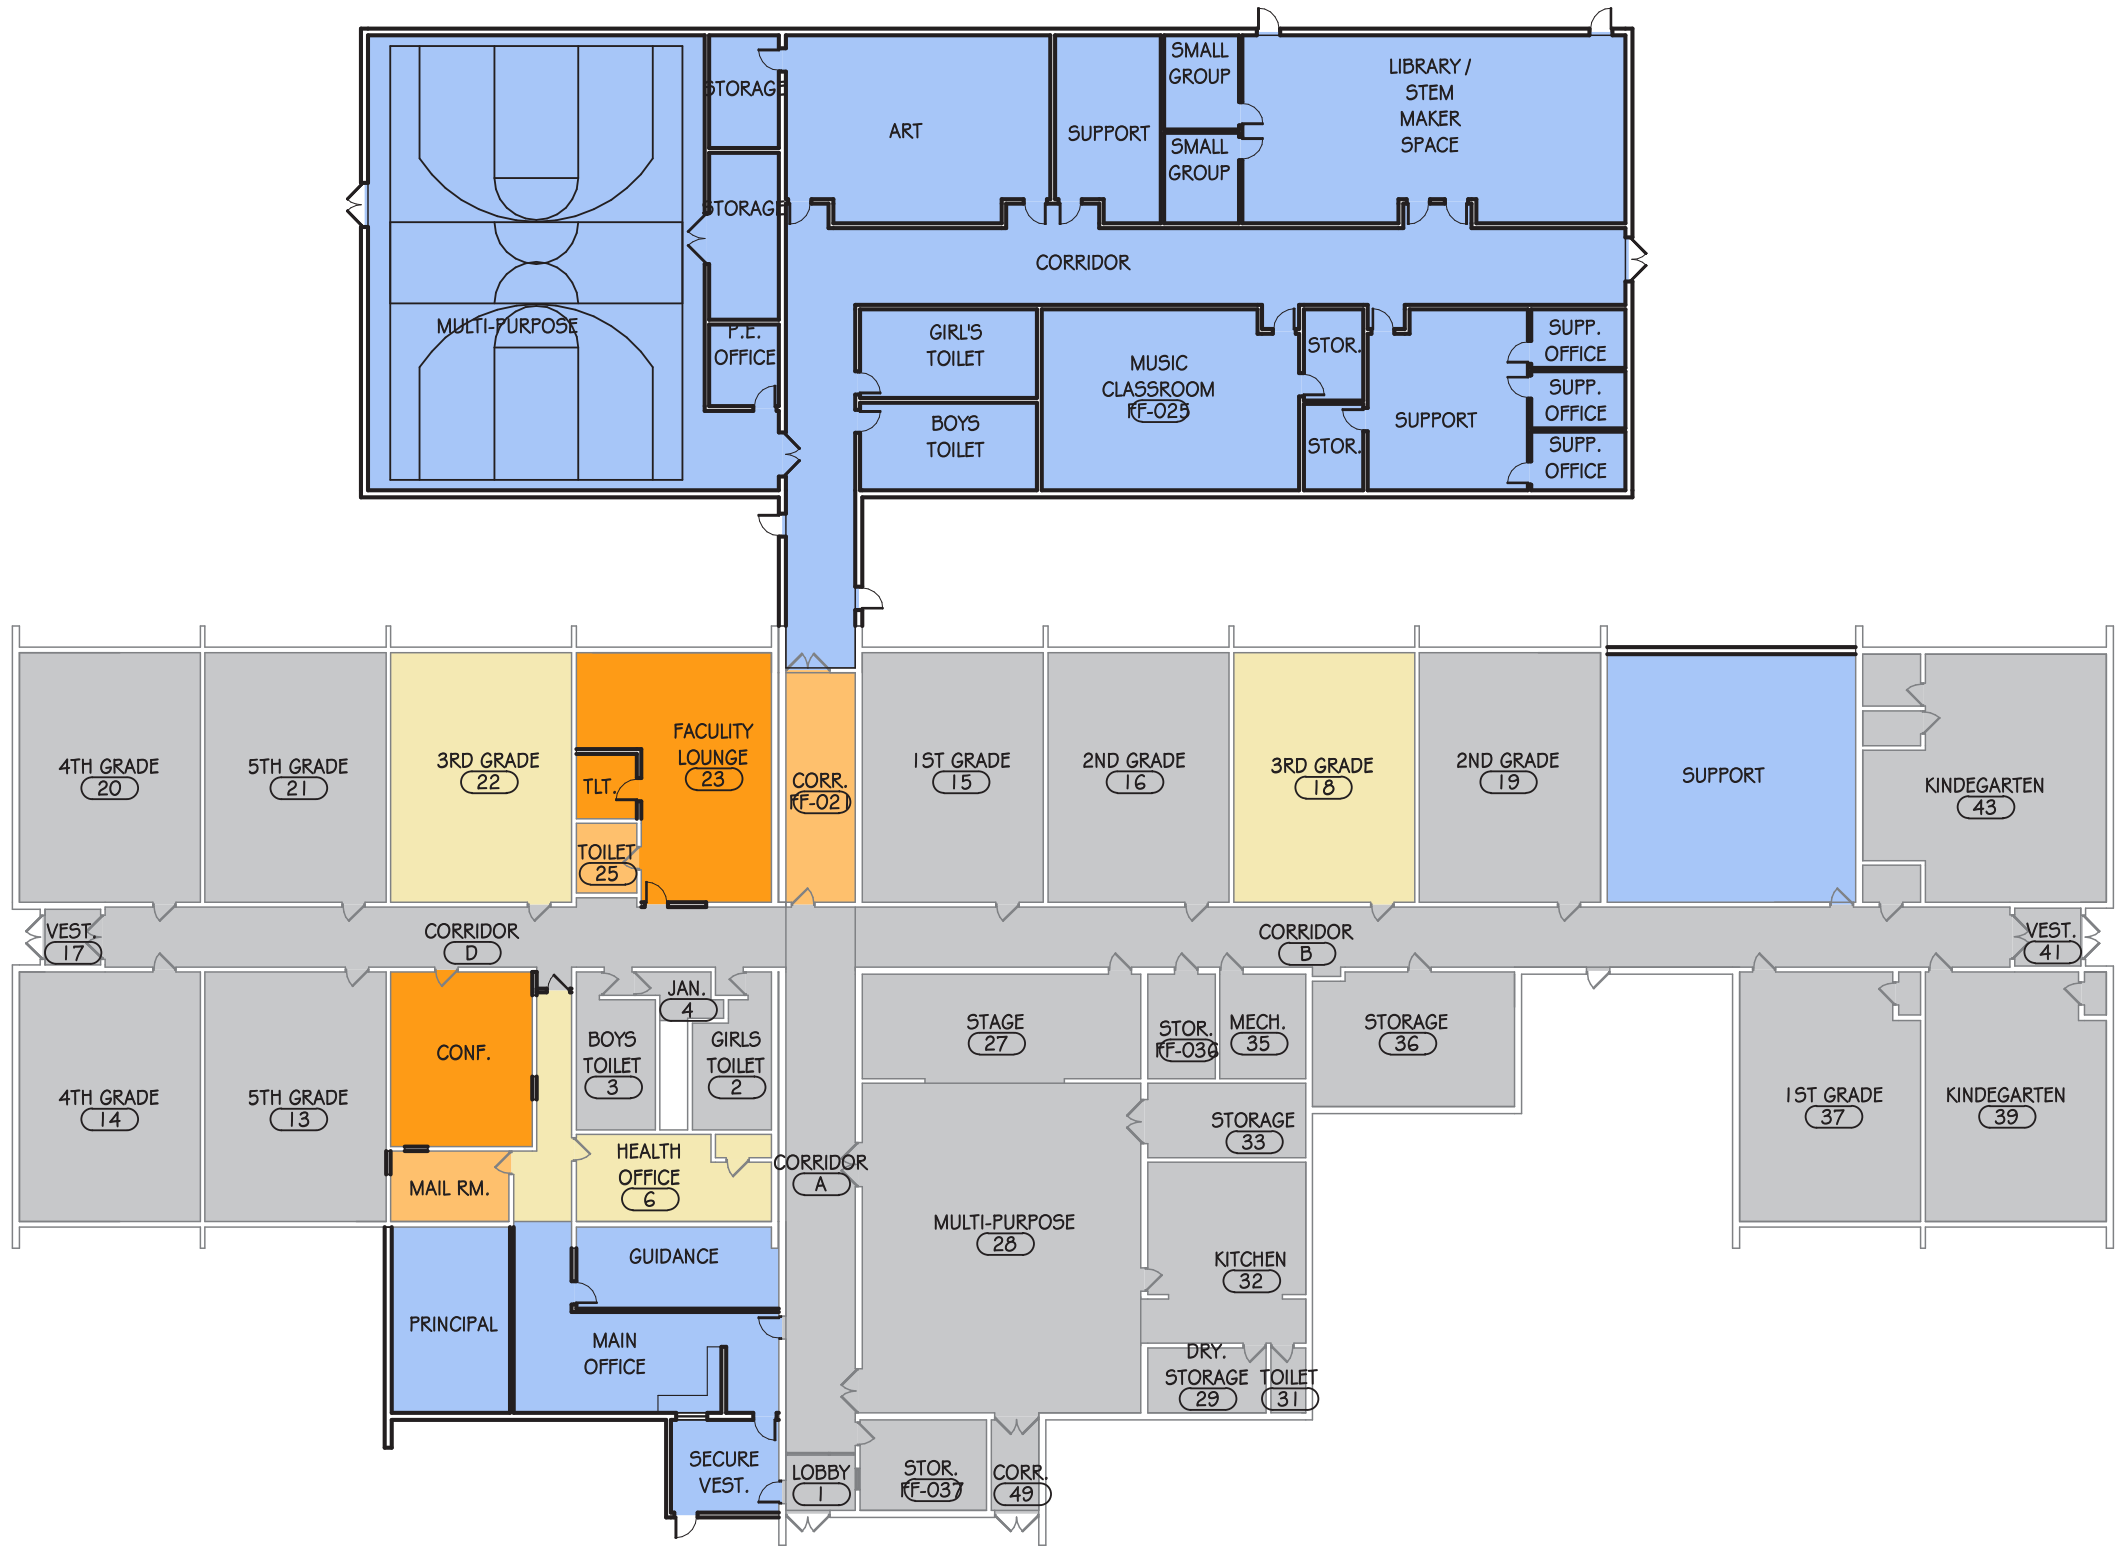
## OPTION 2 FLOORPLAN

- Existing Conference Room and **Faculty Room to be renovated** and updated in the current location.
- Art Room- The existing **Art Room** is not designed for this curriculum. It is recommended that a new Art Room is programmed into the expansion/addition.

- Music Room- The existing **Music Room** is not designed for this curriculum. It is recommended that the existing Music Room is renovated in the current location.

- Temporary Trailers to be replaced with a permanent addition of Classrooms/Spaces. Program to include **updated Library/Maker/STEM space**, 2 Classrooms and 1 Support space.

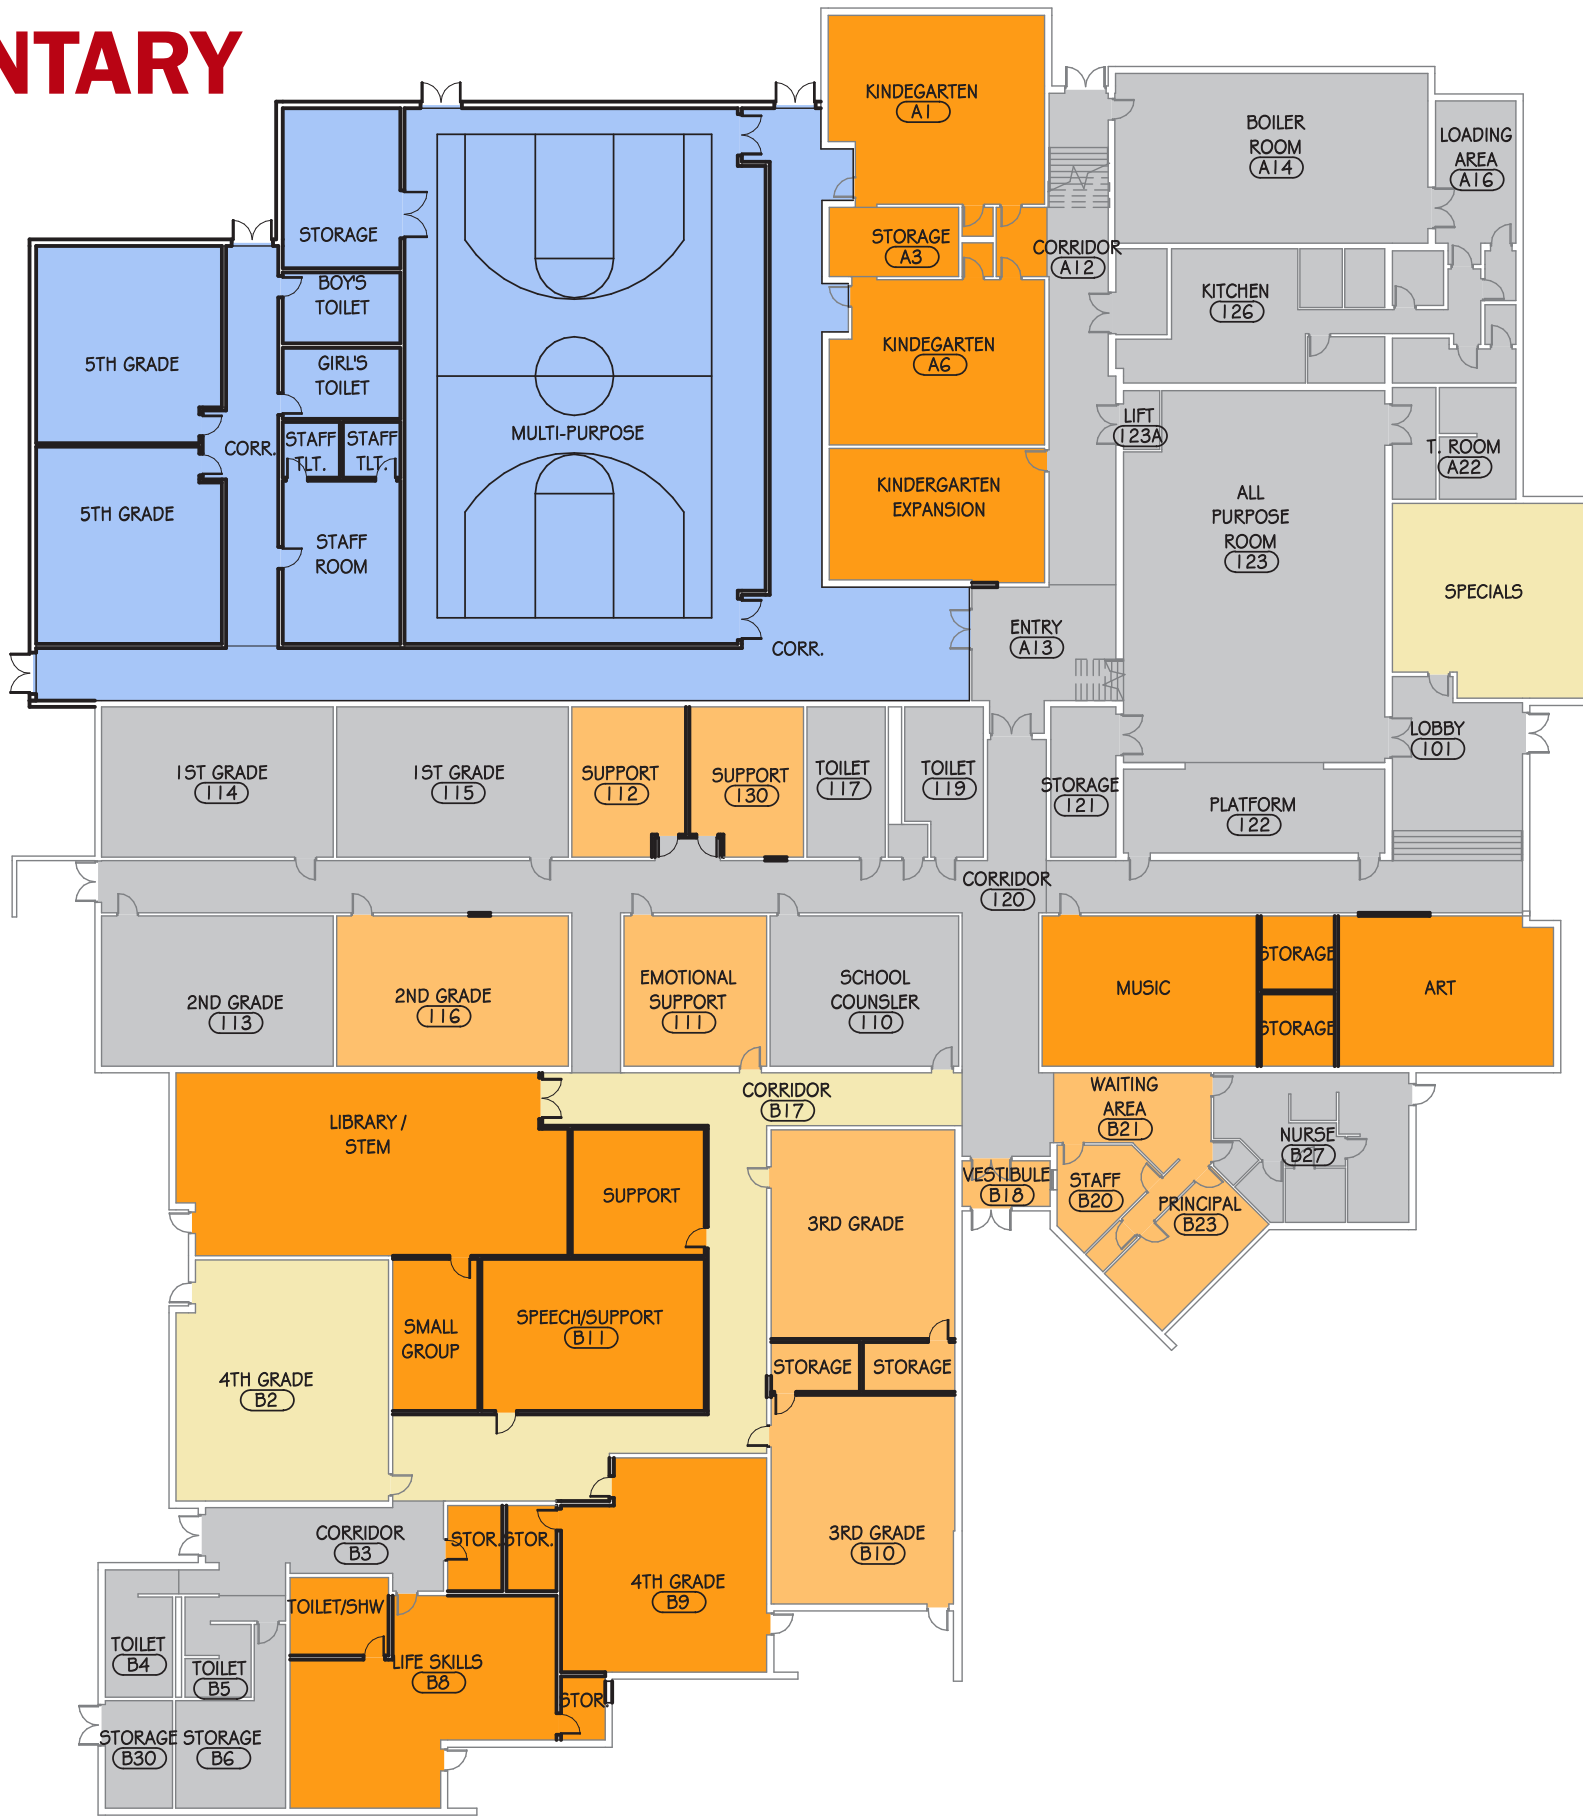
## OPTION 2 FLOORPLAN

- Art and Music Rooms – The existing spaces are a shared space that is not designed for either curriculum. It is recommended that the existing space, plus the adjacent reading room, is renovated into new separate **Art and Music** spaces.

- Classroom sizes- One area adjacent to the Library currently has small **Classrooms** and it is recommended that these spaces are **expanded and renovated** from 3 Classrooms down to 2 appropriately sized Classrooms. One Classroom to be programmed into the addition.

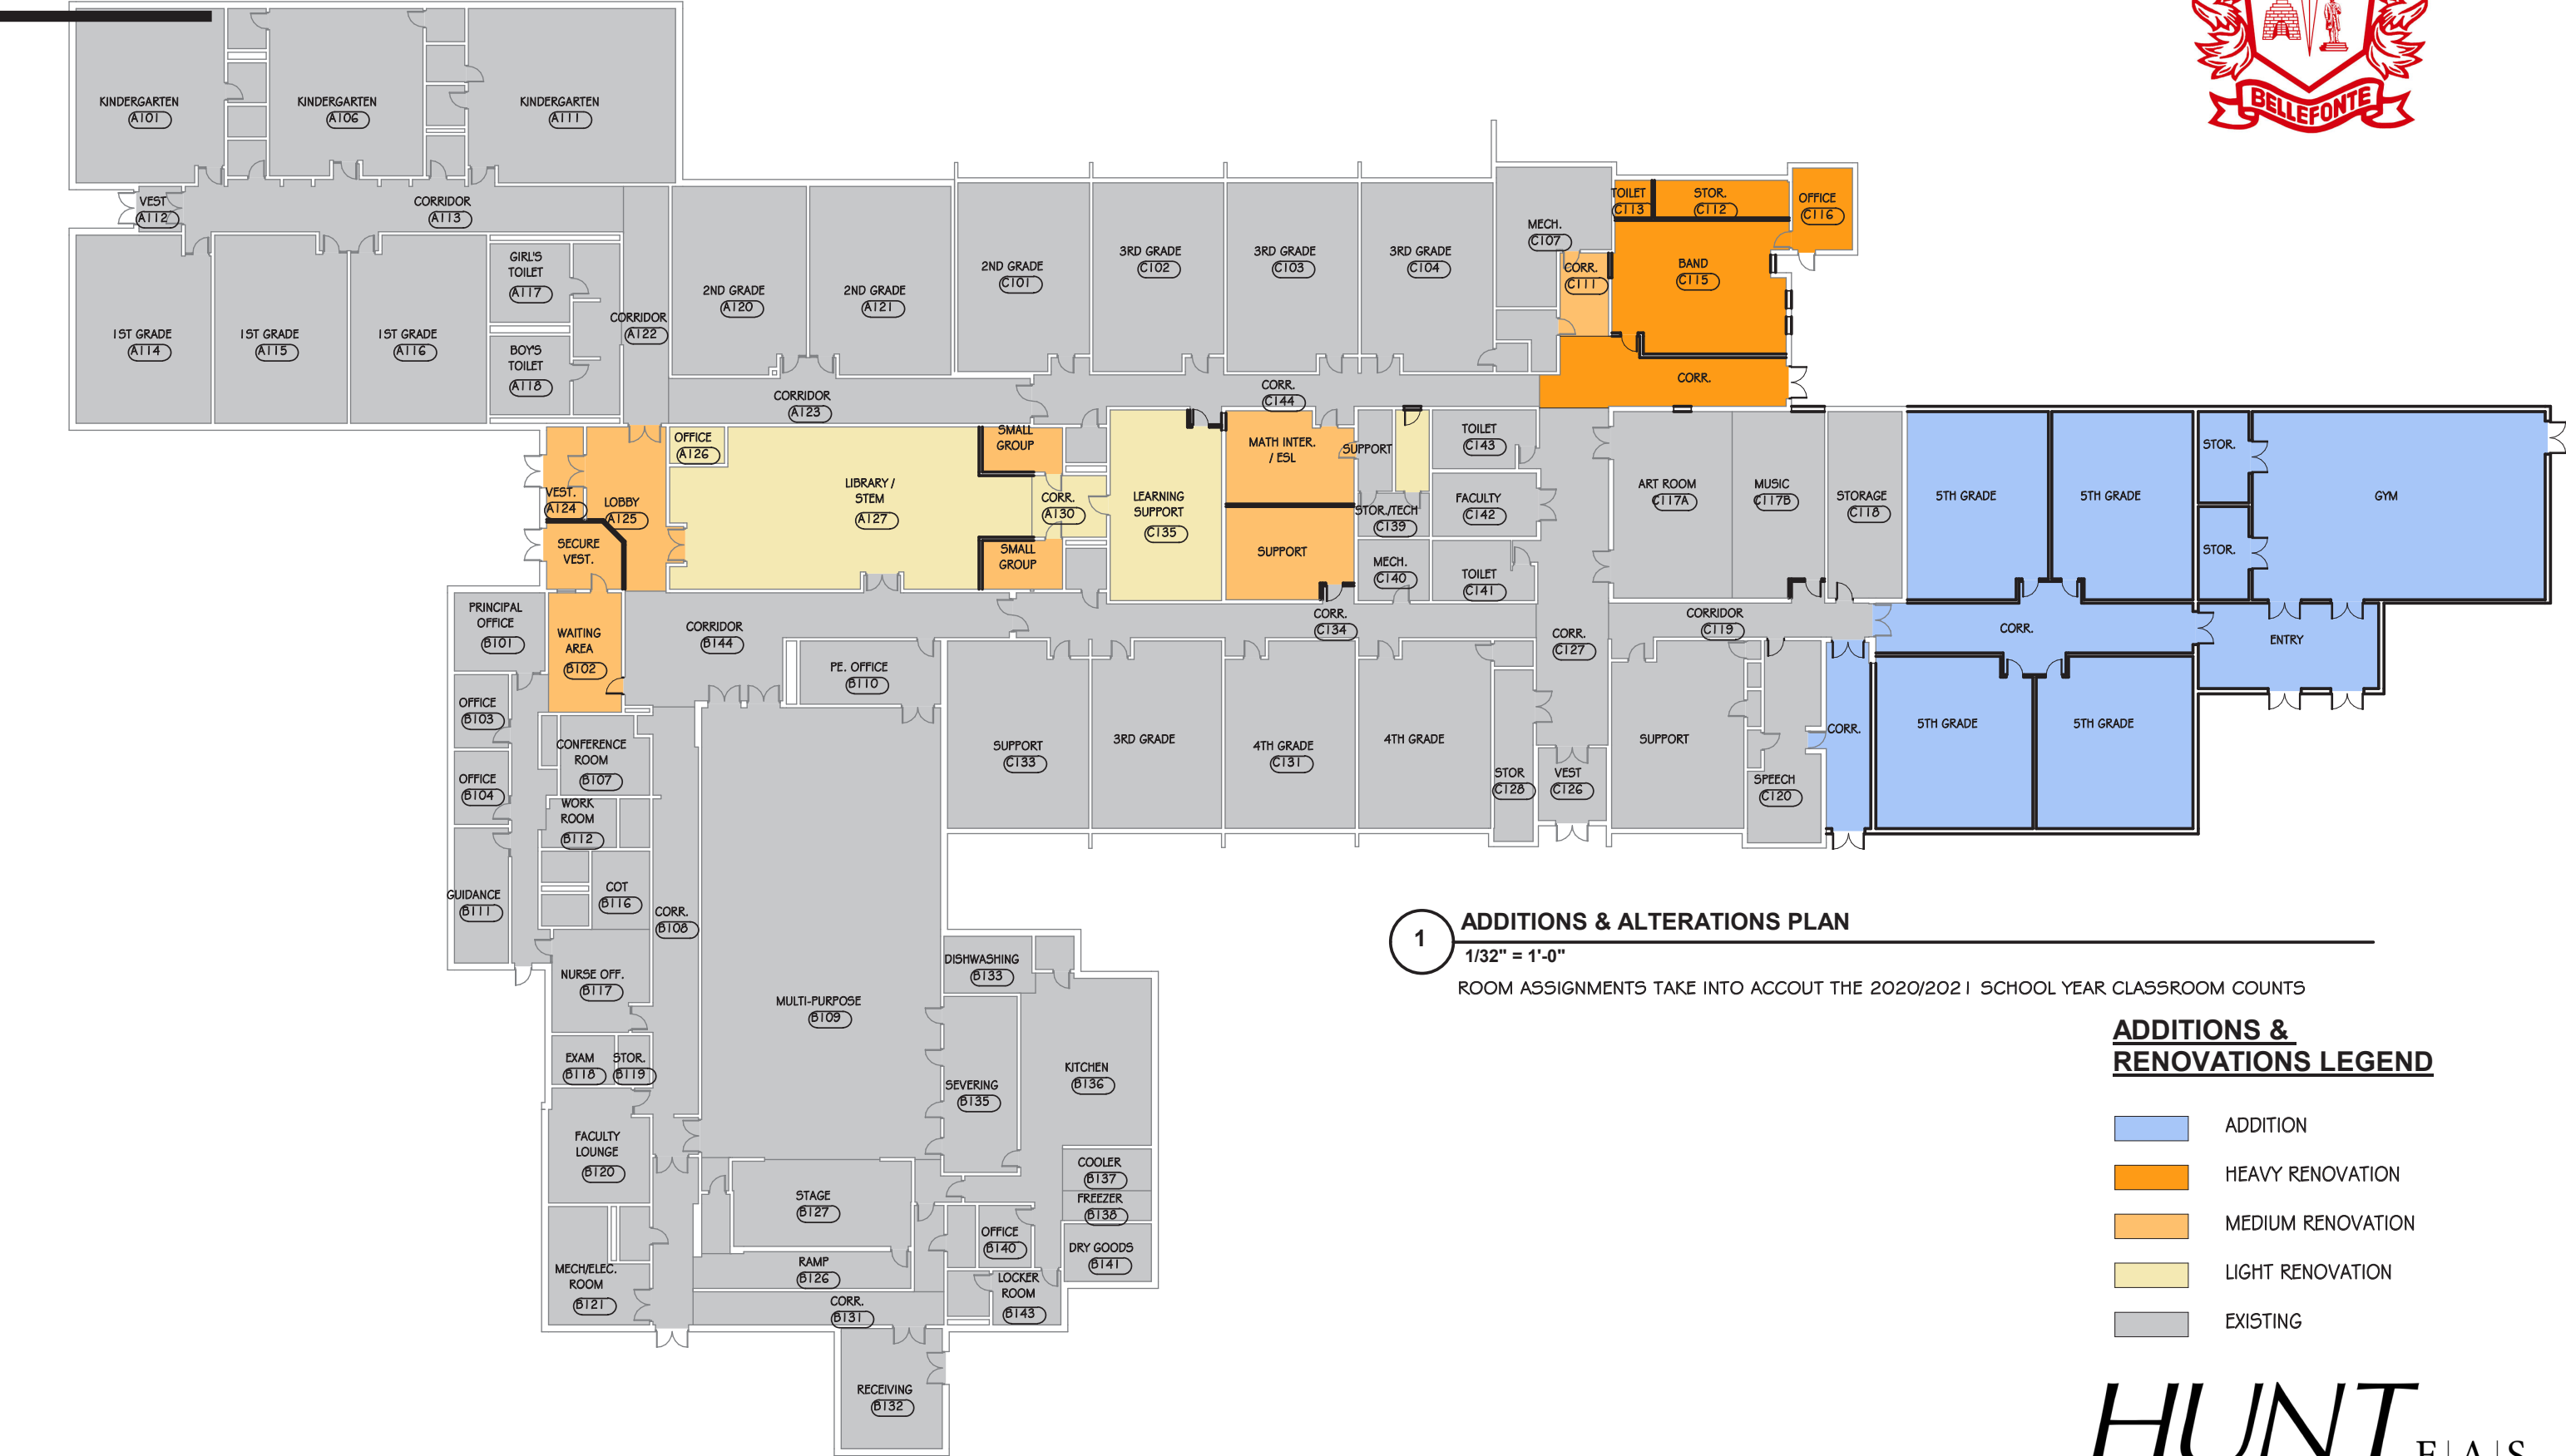
## OPTION 2 FLOORPLAN

- Temporary Trailers to be replaced with a **permanent addition of Classrooms/Spaces**. Program to include 4 Classroom spaces. Provide reconfiguration to the 4th and 5th grade wing to provide efficient spread of support spaces.
